Reversing Falls Sanctuary Roof Notes. August 21, 2013.

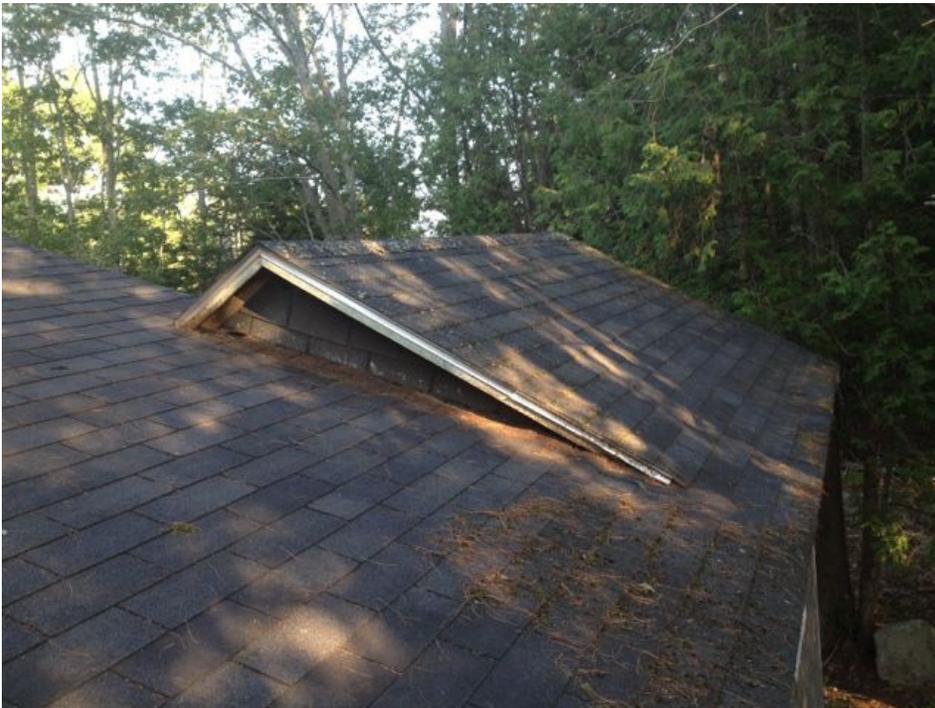
We know that we need to proceed with repairs to the kitchen and back room roof, as was suggested by the insurance inspector several years ago. David has commented that the roof, while not great, will last a couple more years, and the needed repair is at the point where the kitchen and dining room roofs intersect. Doing the whole roof might simplify making the repair into the rest of the roof, but it looks like shingles are flexible and not so sealed down as to make a spot repair too difficult.

The way the roof is set up now, there's a gap as the two surfaces go down to meet, three courses up from the bottom. I would propose to remove the shingles immediately next to and under this overhanging gable, attach solid wood to bring the gable face out flush with the upper roof edge, re-shingle the lower surface with proper step flashing, and face the new vertical boarding with solid flashing tucked under the drip edge above. Trying to get everything watertight when it's recessed

like the current set-up would be difficult, and I think this is a spot where aesthetics of that gable overhang are a lower priority.

The alternative, to maintain the current aesthetic, would be to remove enough upper roof that a new membrane could be laid down flush with the existing gable end wall, and then the new roof edge re-built, but that seems like more work than we need to do.

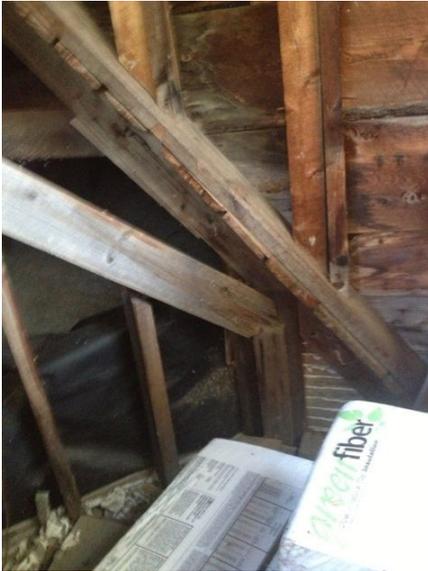
I saw no evidence of dripping on the top of the new cellulose insulation. This makes me think the water marks may be old, but I'm not certain. The way to know is to paint the area of the ceiling and see if the water marks re-appear.

Talking with Ralph, I learned that the tops of the walls were blocked with thin material before the insulation was blown in. There is some diagonal framing in the wall, and sometime when the sun is shining on the south wall I'll have a look with the thermal camera to see what it looks like. Meanwhile, blocking up the bottoms of the stud bays in

the basement will reduce thermal looping and be fairly cheap to do with canned spray foam and scrap material. With that done, at some point in the future we could poke through the top blocking and blow loose cellulose in the walls. This would be an incomplete job, but better than nothing. Eventually it would settle and need to be topped off.

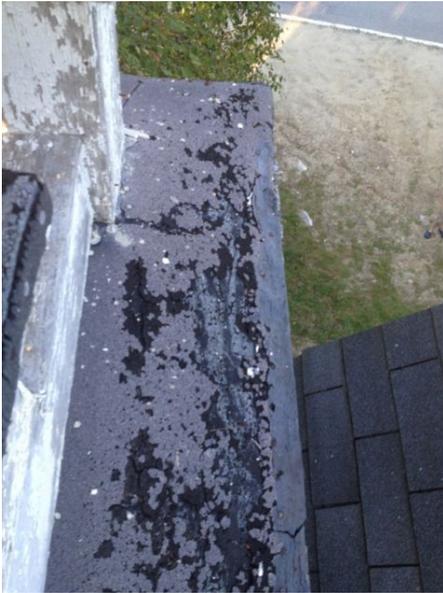
I noticed the whole belfry wiggled slightly when I shifted my weight back and forth quickly. The structure seems pretty solid, but would benefit from some diagonal

There is a hatch to the upper steeple interior, and looking up through this I saw several holes in the roof, one quite large. There is also a lot of mold and water staining. I hope that if we can get to it promptly, we could sister the framing where necessary, put on new sheathing, and shingle it. If we wait too long, the simple answer will become to take down the bell and remove everything above it, replacing the belfry floor with a short pyramid roof.

bracing in the middle level, below bell level. It would also help to have a proper ladder, permanently installed, from sanctuary attic level up to the bell level hatch.

I'd hate for it to come to that though. I recognize that the belfry and steeple are a flourish on a building that has many other pragmatic needs, but I think it's an important flourish. I'll discuss with David what's within our capabilities.

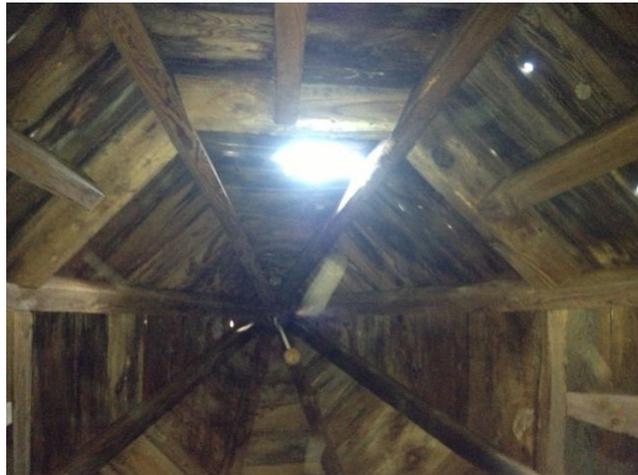
On my way down I looked at the shot out window. The round sash is held in with nails around the edge. The easy way would be to bring up glass, points, putty, and glass cutter. That's not a hard job.
